***Ducted Systems
Technical Services
Service Tips Letter***

Letter: **ST-007-2018**

Subject: **Condensate dripping issue with Residential Early production model CM indoor coils applied in a horizontal application.**

Product: Residential CM Model cased coils: AP, AE, AVC, RFCX**22 air handling units.

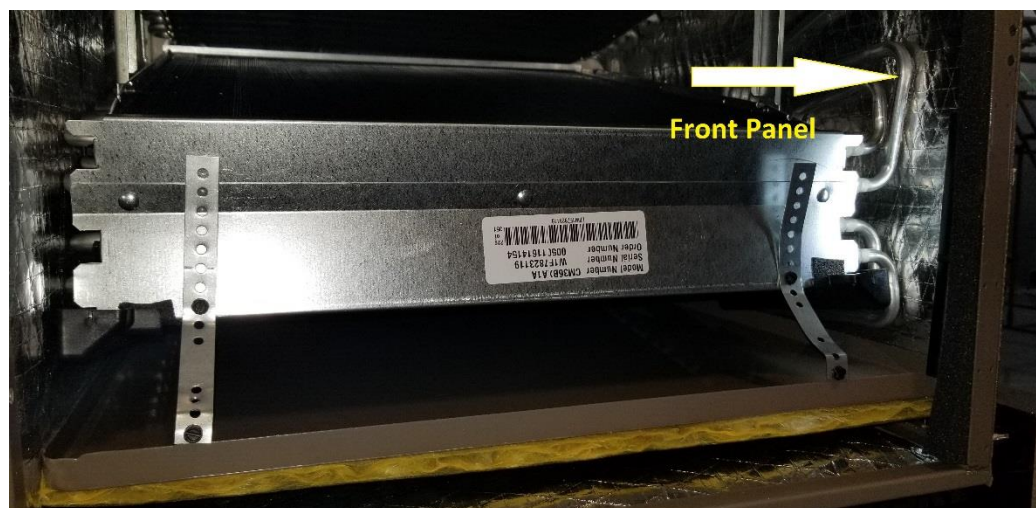
Through our investigation, we discovered that the distributor assembly, tubes, suction header and TXV body of the coil may be pressing against insulation of the front panels of the coil case, which is shown below.

When condensation is formed during normal operation, the condensation has the ability to make contact with the insulation face and travel down the foil surface. Due to the design of the first generation horizontal drain pan, the drain pan may be unable to capture all of the condensation coming off the front of the coil.

Based on these findings, Design Engineering implemented a wider horizontal condensate drain pan in July of 2017. The drain pan can be identified by the edge connected to the horizontal pan straps. The first generation drain pans had a 45-degree edge. The current drain pan has a 90-degree edge. The drain pan edge was changed to improve condensate management within the pan. Shown below is a picture of the current drain pan that now has an interference fit with the insulation on the back coil cabinet and front panel. Coils produced in August 2017 (W1H7) and later contain the new wider drain pan.

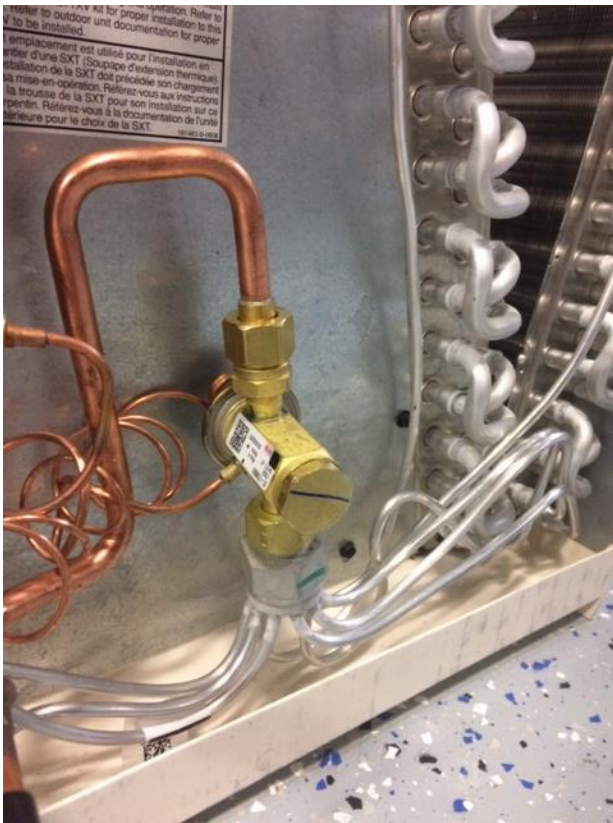
INCORRECT INSTALLATION

Another issue that may lead to condensate not managed properly, is the installation of the TXV to the distributor body. The improper orientation or position of the TXV can allow it to protrude into the insulation on the door panel. This may cause the condensate on the foil surface to drain around the pan. When installing the TXV, make sure that the TXV body is oriented parallel to the delta plate as shown in the unit installation manual. See photos below.
