***Ducted Systems
Technical Services
Service Tips Letter***

Letter: **ST-014-2018**

Subject: **3-12 ton Packaged Reheat – Resolution of 3-way valve issue.**

Product: **Series 10, Predator, Outfitter, Ovation, ReliaCore 300, OmniCore 300**

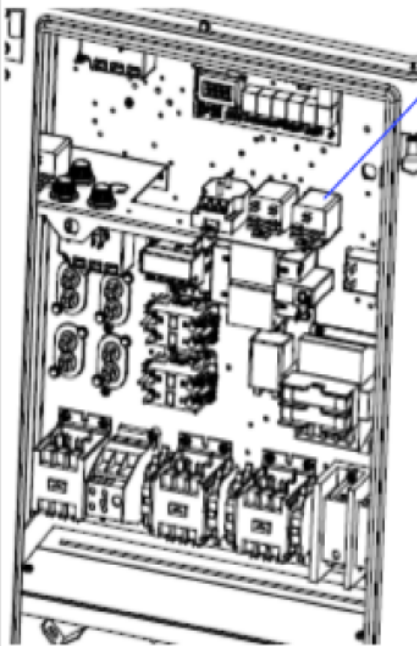
Figure 1.

1. Open the controls access door and locate the reheat relay, as shown in Figure 1
2. Disconnect all wires from the reheat relay and remove the (2) screws securing the reheat relay. Discard relay

The following instructions are to provide direction to replace the current RHR (SPDT) with a (DPDT) relay with the addition of a Time Delay Relay. The purpose of this change is to provide a brief interruption of the compressor at the initiation of a call for dehumidification only and allow the Reheat Valve to fully shift to the reheat mode.
