Letter: **ST-008-2020**

Subject: **Blower motor noise during shut-down – Regal Beloit Ensite® Blower Motors.**

Product: TM8X, TMLX, TM9X, TM9E, TM9Y, RGF19\*E, RGF29\*E, RGF1L\*E, RGF2L\*E, MM9E

Summary: **This letter provides explanation and resolution for complaints of blower motor noise occurring during motor shut-down.**

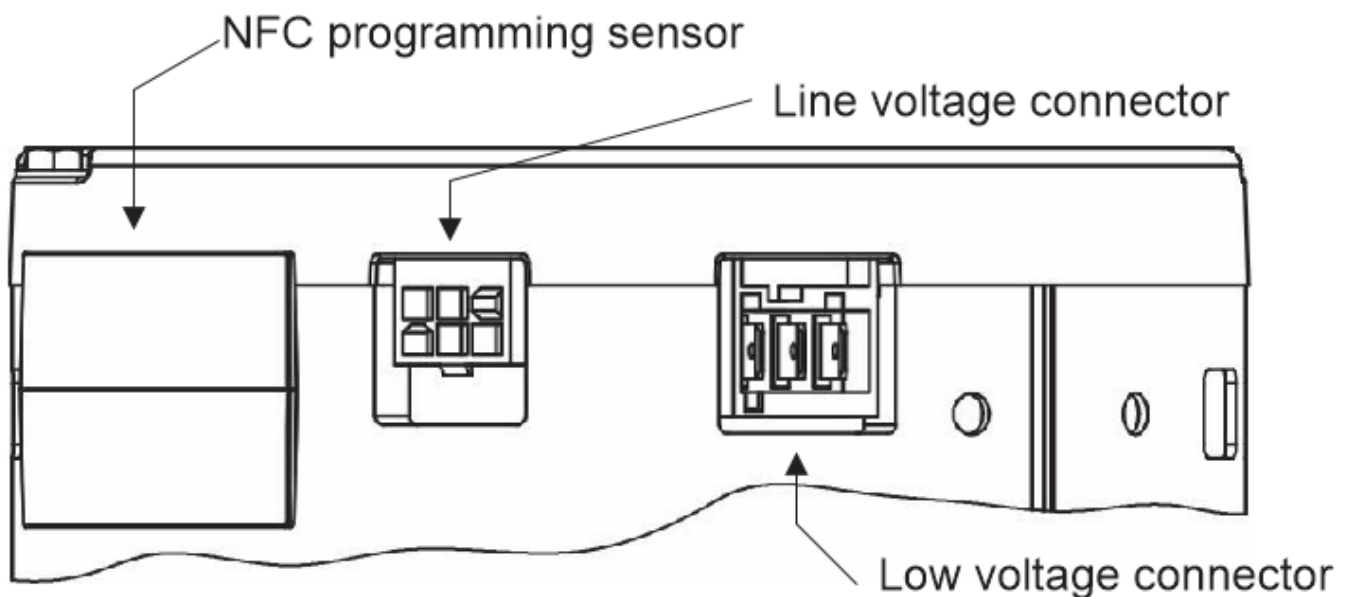
Starting in early 2019, some furnace blower motors have been changed from Regal Beloit EnduraPro® motor to the Regal Beloit Ensite® motor. The Ensite® motor has several unique features to differentiate it from the EnduraPro® motor. The motor is lighter in weight, has better performance, can be programmed using NFC (near field communications) and the electrical connections are on smaller simple connectors in lieu of individual speed tap connectors. The Ensite motor can be easily identified by its unique electrical connections. An image of the Ensite motor connections is shown below.

We began to receive complaints of excessive blower motor noise occurring during the motor shut down (coast down) process. Further investigation revealed that the Ensite motor took much more time to shut down when compared to the previously utilized EnduraPro® motors. The rotational modulating tone heard at lower speed

during coast down is the motor and wheel torsional resonance. The amplitude of the noise varies with application and installation, but with the Ensite® motor & our blower housing system resonance, the noise peaks on low rpm. The size of return air duct amplifies the noise as well as other site-specific conditions. This noise most likely could be remedied by using acoustical duct liner inside the return air duct which is common in many commercial installations.

By enabling the motor’s brake option, the motor will slow much quicker through this resonance minimizing the effect. We enabled the braking on some motors and sent them to various field sites experiencing the shut-down noise described above. The issue was resolved at every one of the field sites with the replacement motor.

Due to successful field trials, the decision was made to enable the braking option. All factory furnace production after 6:45 AM on 03/04/20 contain motors with the updated program. All Source One Ensite® programmed motor inventory was placed on hold. Each motor was reprogrammed with the updated program. Any Source One Ensite programmed motor shipped after 4:30 PM on 03/03/20 contains the updated program.

If a customer experiences the shut-down noise described above in a furnace built before the date above, the motor should be replaced under standard unit warranty. For distributors that program their own motors in house, the installed trouble motor could be re-programmed however it would not be practical for a dealer to remove a motor, have it re-programmed at the distributor location, then return to the site for installation.
