Unitary Products Technical Services Service Tips Letter

Letter: **ST-002-2018**

Subject: **Ignition control board defect**

Product: Residential single stage PSC gas furnaces.

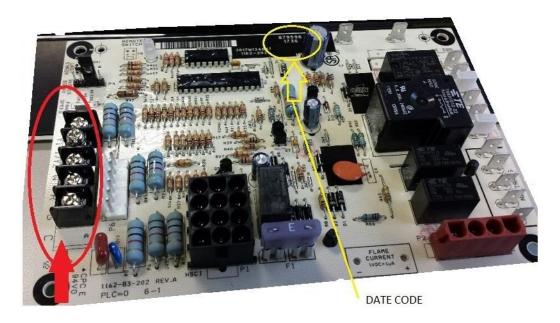
It was recently discovered that the control board low voltage terminal block has inadvertently been shifted over one space leaving the field wired COMMON connection to the control with no terminal to connect the field supplied thermostat wiring to. According to the control board manufacturer, the affected date code of the board is 1736. This defect is limited to a very small number of control boards. We have received reports of only **TWO** incidents to date of this defective board issue. Below is a photo of a defective board.

Note the red circle and arrow. This illustrates the missing 24VAC thermostat common connection. The location of control board date code is circled in yellow.

If a control board defect of this type is found, please report it to the Residential Distributor Support team as we will require the control be returned to us for vendor analysis. The control board can be replaced with S1-33103010000 and claim one hour labor using the standard unit warranty. If further information becomes available, it will be provided with an update to this letter.

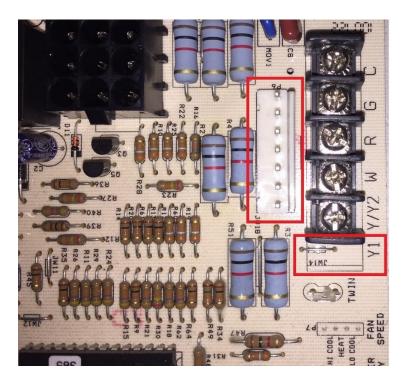
Note the red rectangle outline with the wire jumper inside it. It is labeled Y1. This is correct for the single stage PSC model control board.

Each and every furnace goes through a factory run test and must pass it prior to being packaged and shipped out. In the photo above there is a red rectangle outline around a plastic low voltage connection header labeled "P6." The run test station on the assembly line connects to this P6 connector in lieu of connecting to the field thermostat wiring connection screw terminals. Since run test does not connect to the screw terminals, the furnace control was able to pass run test.
